**RE: Baruch College - Site "B"**  
Contract #16 - GC #2  
Epoxy Terrazzo - Uplift/Debonding

### PRELIMINARY SITE INVESTIGATION REPORT

<b>Client:</b>	TDX Construction Corp.	<b>Lab #:</b>	Pending
<b>Project:</b>	Baruch College - Site B	<b>Report #:</b>	ML-01
<b>Address:</b>	55 Lexington Avenue New York, New York	<b>Field Visit Date:</b>	03/04/03
<b>Construction Type:</b>	Terrazzo flooring system on concrete slab	<b>Report Date:</b>	03/05/03
		<b>Petrographer:</b>	J. Walsh
		<b>Page 1 of 10</b>

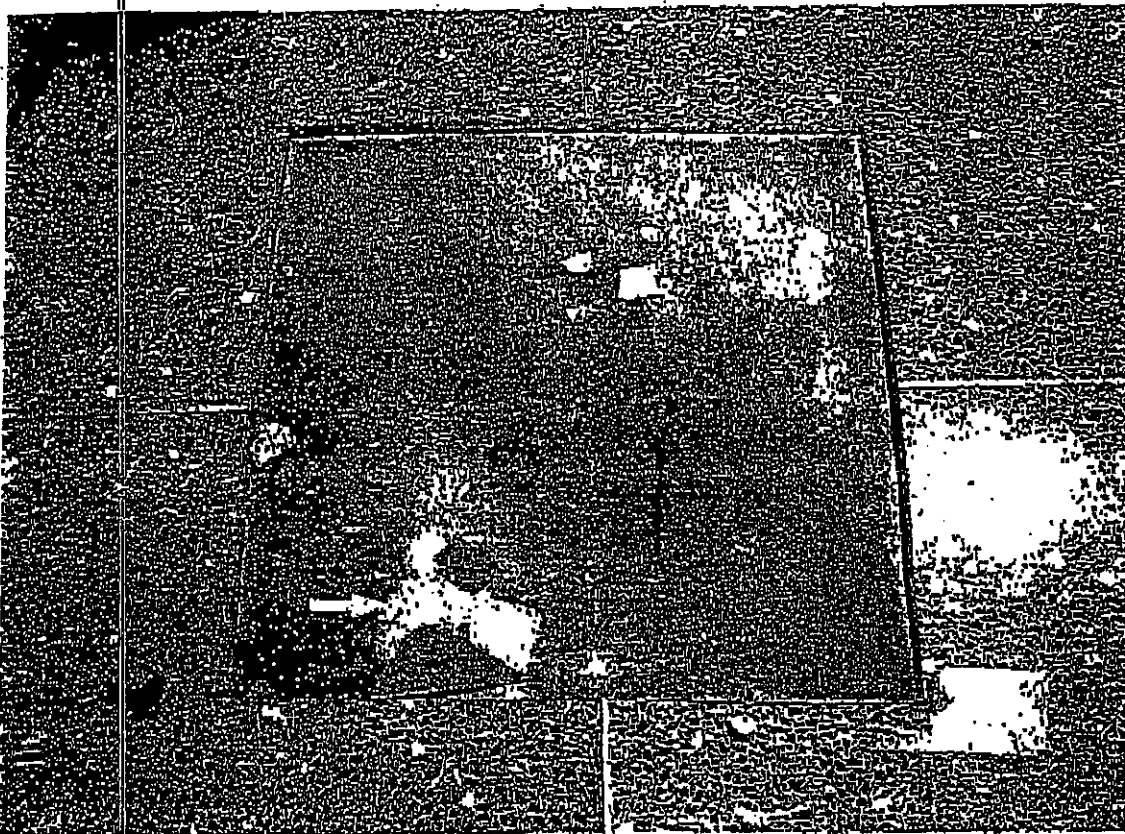
Figure 5: Probe location B1. The epoxy membrane is completely debonded from the smooth self-leveling compound surface. In the lower left quadrant (arrow), the self-leveling compound is clearly debonded from the concrete substrate. Sounding indicates that the debonding is present nearly everywhere below that one corner.
